Failure analysis of corroded heat exchanger CuNi tubes from a geothermal plant

This study examined the premature failure of cupronickel (CuNi10Fe) tubes in a shell-and-tube heat exchanger after five months of service. An investigation to identify the root cause of the tube burst was carried out using macroscopic and microscopic inspection, chemical analysis, and mechanical analysis. The optical microscopy (OM) and scanning electron microscopy (SEM) evaluation revealed crack propagation characterized by pits and inclusions at the tube surface. This was due to the diffusion of hydrogen ions into the material from the hydrogen sulfide (H₂S) rich geothermal environment. Furthermore, high tensile residual stresses of 172 MPa were recorded in the failed tube, leading to stress cracking in hydrogen-containing material. Additionally, the high sulfide content in corroded water and condensate samples suggests that the leading cause of tube rupture was through hydrogen embrittlement and sulfide stress cracking mechanism in the presence of hydrogen sulfide. Therefore, the use of laser cladding to protect tubes using functionally graded materials is recommended to mitigate degradation in aggre

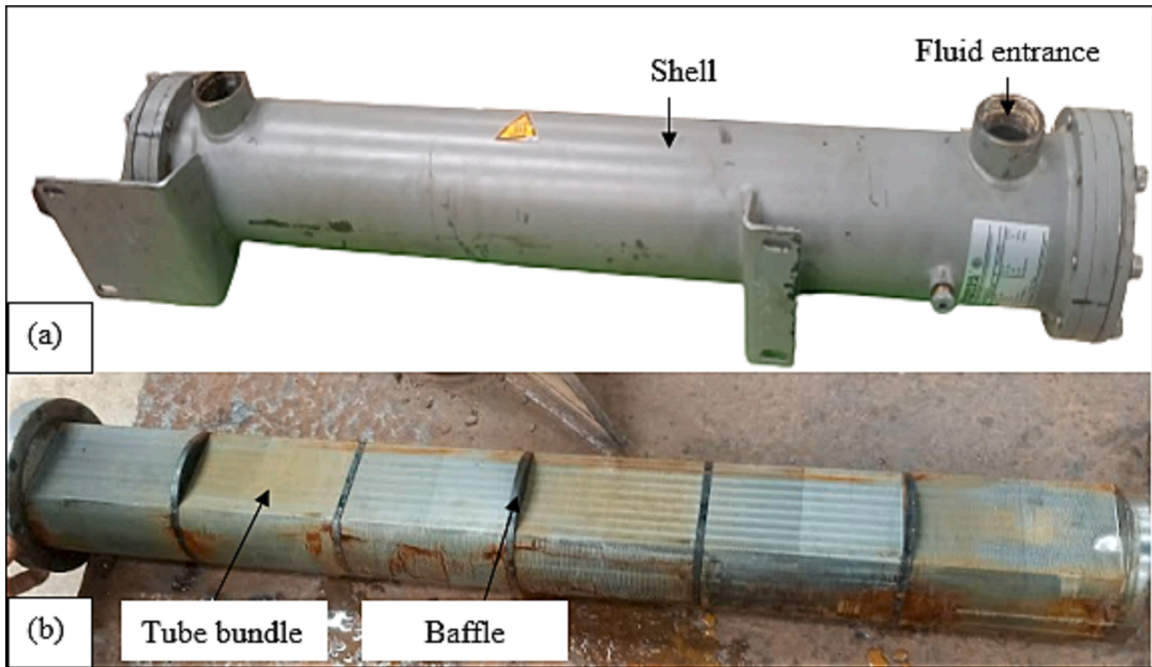
Fig. 1. View of the failed shell-and-tube heat exchanger, (a) general view of the exchanger and (b) internal assembly of the tube bundle.

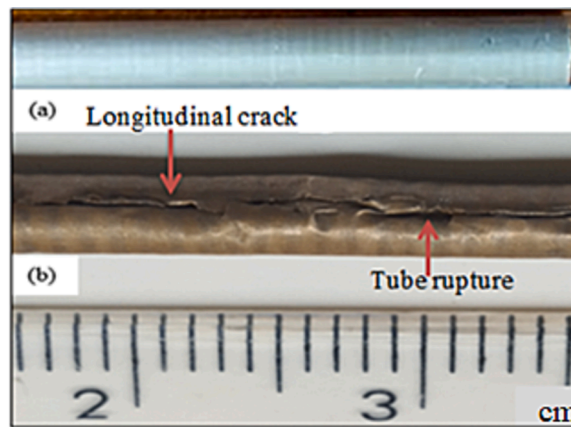
Fig. 3. Investigated heat exchanger tubes (a) intact tube, T1 (b) failed tube, T2.

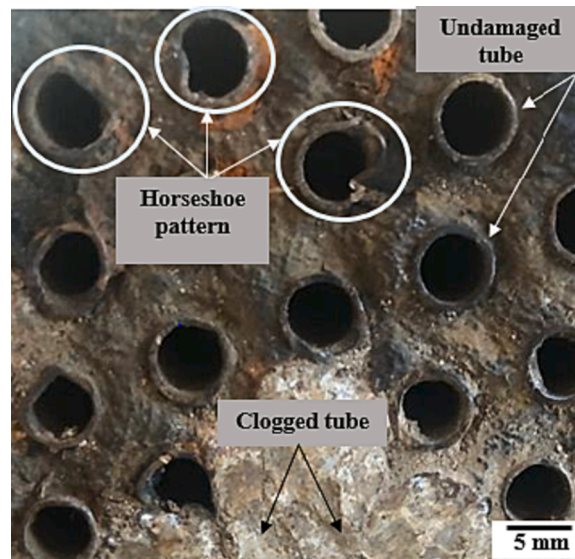
Fig. 5. Top view of the failed heat exchanger tube bundle.

The results of the visual inspection are interpreted in light of the mechanical study to clarify the mechanism by which the visible failure features emerged. Fig. 5 shows the cross-section of the virtually inspected stacked exchanger tubes. White blockage media introduced to the exchanger by the Olkaria Company were observed at the tube end (see Fig. 5), and found to correspond to the blocked dysfunctional tubes. On the contrary, the tubes at the outer region of the bore appeared to be in good shape and to be working properly. To confirm this, the pressure was blown through the pipe and dysfunctional tubes were identified by leakage sound. This may indicate that corrosion predominantly took place at the centre because cracking was primarily concentrated at the tube bundle's centre and stretched along the tube's longitudinal direction, as illustrated in Fig. 3b. This could also be due to the shell side turbulent pressure concentrated at the centre, implying that the exchanger failure emanated from the centre tubes due to high stress concentrated regions.

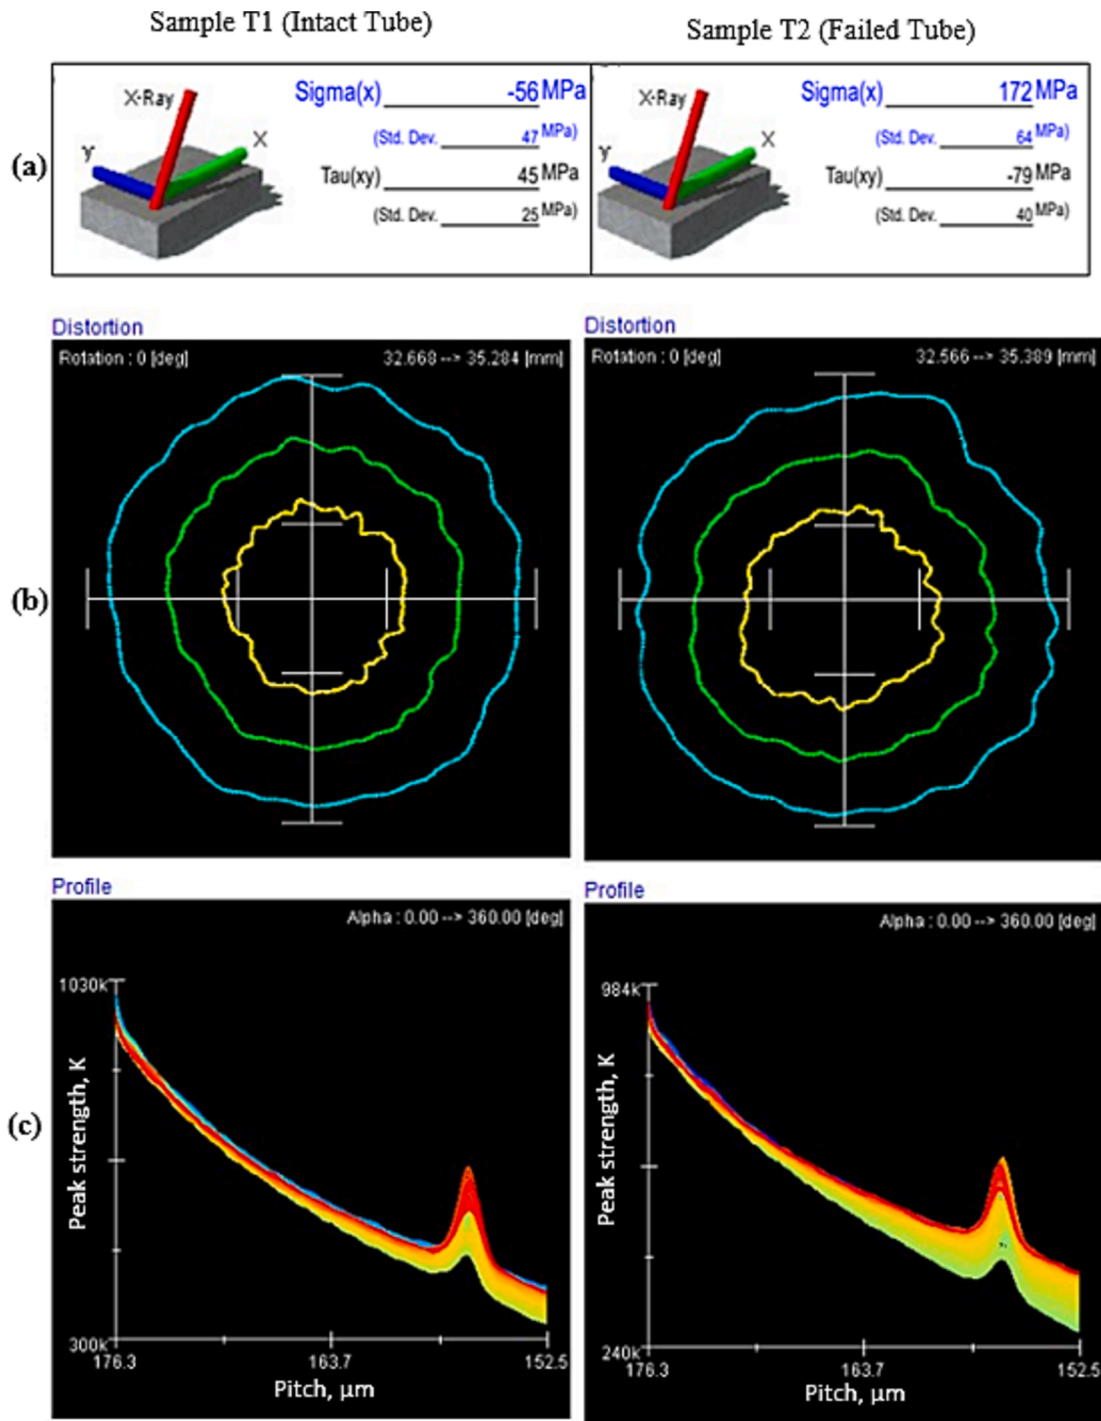
Fig. 6. Measurement of internal residual stresses at tube surface compared for sample T1 and T2 (a) stress values (b) distortion (c) residual stress profile.

Fig. 6 (a) that the failed tube has tensile residual stresses of positive 172 MPa, while the intact tube has compressive residual stresses of negative 56 MPa. The failed tube’s distortion (Fig. 6b) is also higher than the undamaged tube’s due to high-stress concentrations, measuring 2.823 mm, which supports the explanation behind the expanded region of the failed tube observed in Fig. 4b. Furthermore, the intact tube is more accurately depicted in Fig. 6b with a circumference that is close to circular, as opposed to the failed tube Fig. 6b with a more distorted shape. In contrast, the failed tube’s peak profile in Fig. 6c featured a thick peak profile with a yellow–red line signifying high-stress intensity.

- The presence tensile residual stresses indicate that the stress build-up accumulated along the longitudinal region of the tube. Hence, tube rupture occurred in the same direction as cracks in the microstructure induced by diffusion of hydrogen atoms. Excess residual stresses may be reduced by post-processing such as heat treatment.

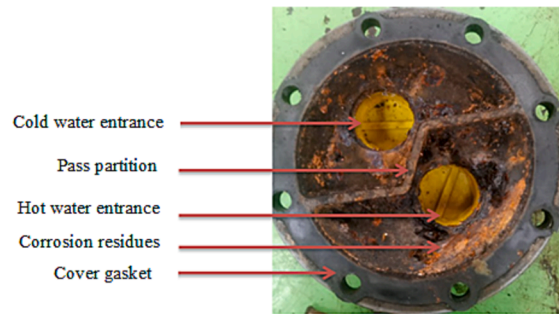
Fig. 7. Corroded heat exchanger cover showing brownish-to-red corrosion products with black layers.

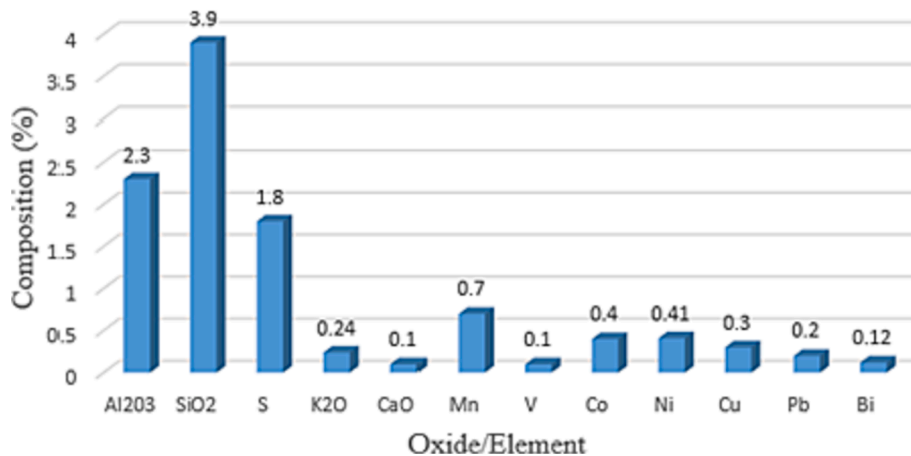
Fig. 8. Elemental distribution and composition of corrosion residue.

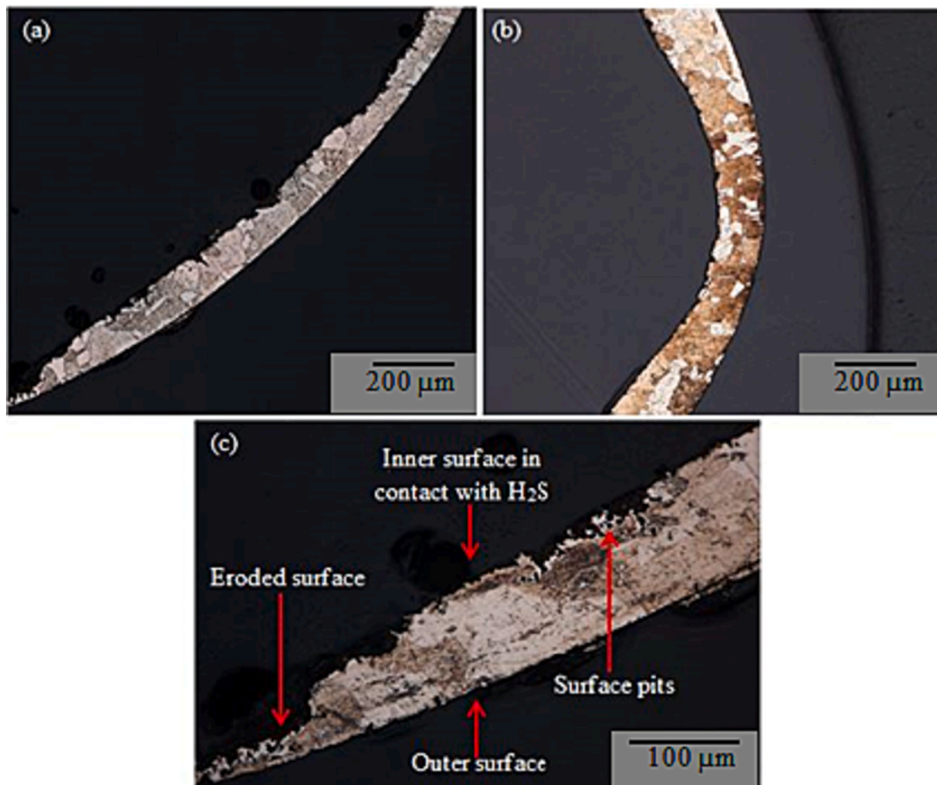
Fig. 10. Micrographs of heat exchanger tubes (a) failed tube with surface defects (b) intact heat exchanger tube with less surface distortion (c) surface cracks pits growing from the inside.

The optical micrograph in Fig. 10 shows the microstructure of the failed tube. Thinning of the tube lining characterized by surface pits can be seen along the surface. The presence of a grooved surface could mean the penetration of hydrogen into the material when it comes into contact with H_2S . In the examined case, it is apparent that the direct contact of the cupronickel surface with degrading impurities particularly sulfides, resulted in perforation of the tube surface.

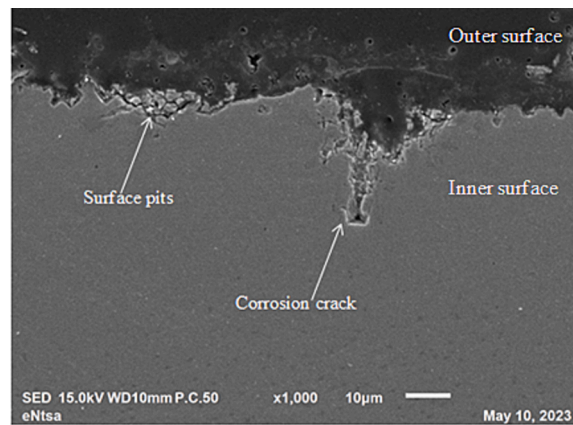
Fig. 11. SEM morphology of sulfide-induced degradation at the tube lining.

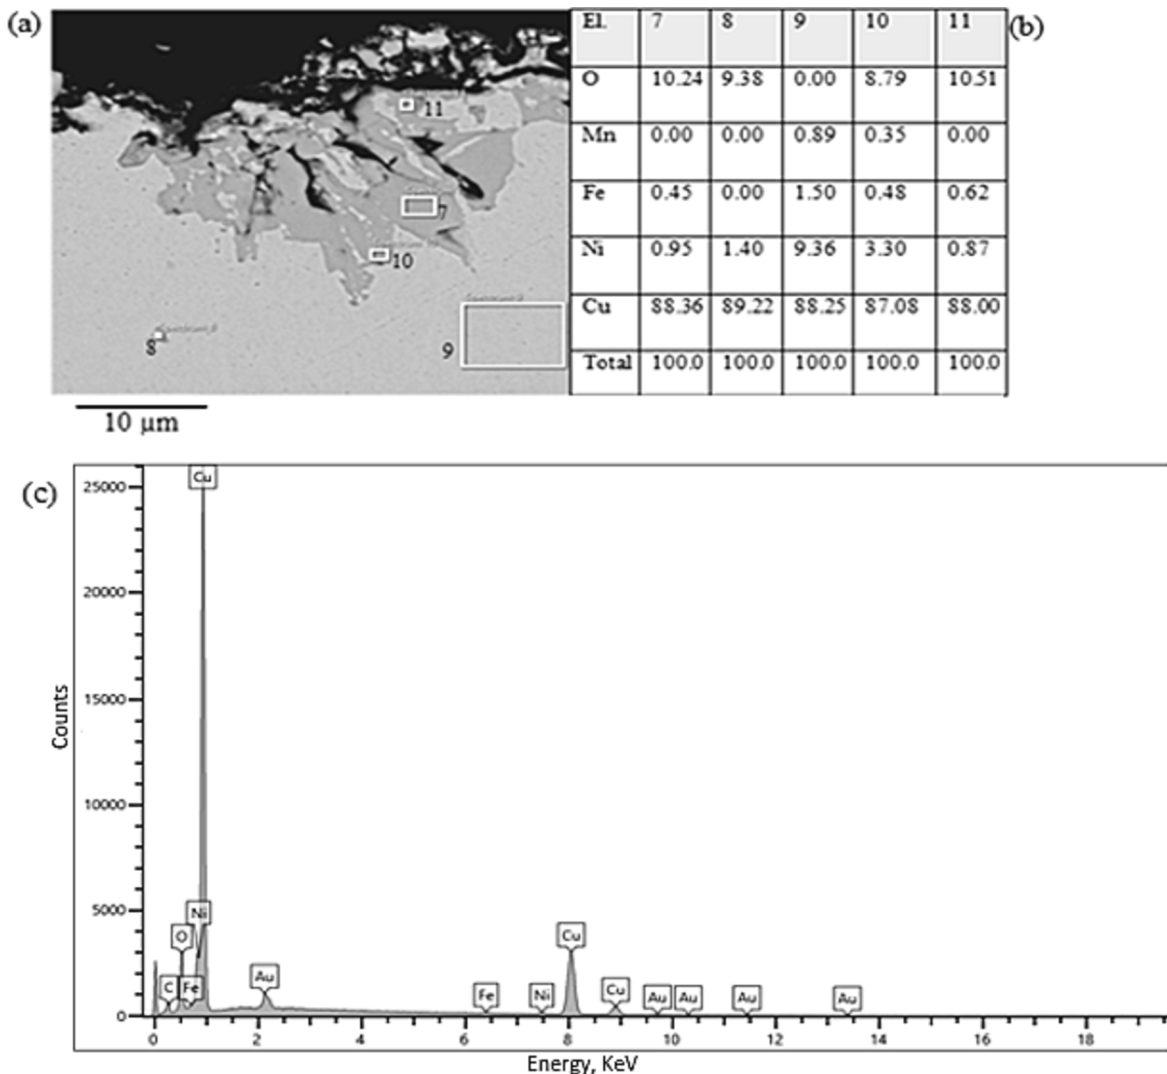
Fig. 12. Metallurgical analysis of the external fractured zone (a) morphology of inclusions and EDS mapping points (b) EDS spectrum of the highlighted zones at the edge.

The EDS mapping of the ruptured pipe in five regions is shown in Fig. 12 (a). Spectrums 8 and 9 were taken in the region containing the cupronickel tube material, while spectrum 11 was obtained in the outer region with corrosion deposits, and spectrums 7 and 10 at the surface of the tube where surface pits, splits, and inclusions are present. Spectrum 9 has a balanced Fe and Mn because it was taken at a region without defects, resembling the standard CuNi strengthening elements. Moreover, it does not have oxygen content to show the absence of oxides from the oxidation reaction. However, high oxygen content in the range of 8.5–10.5 could be seen in spectrums 7, 8, 10, and 11. This indicates the presence of oxides at the tube surface, which penetrated the material to cause degradation. The process of oxidation depletes the iron and manganese strengthening elements in spectrums 7, 8, and 11, where the crack propagates.

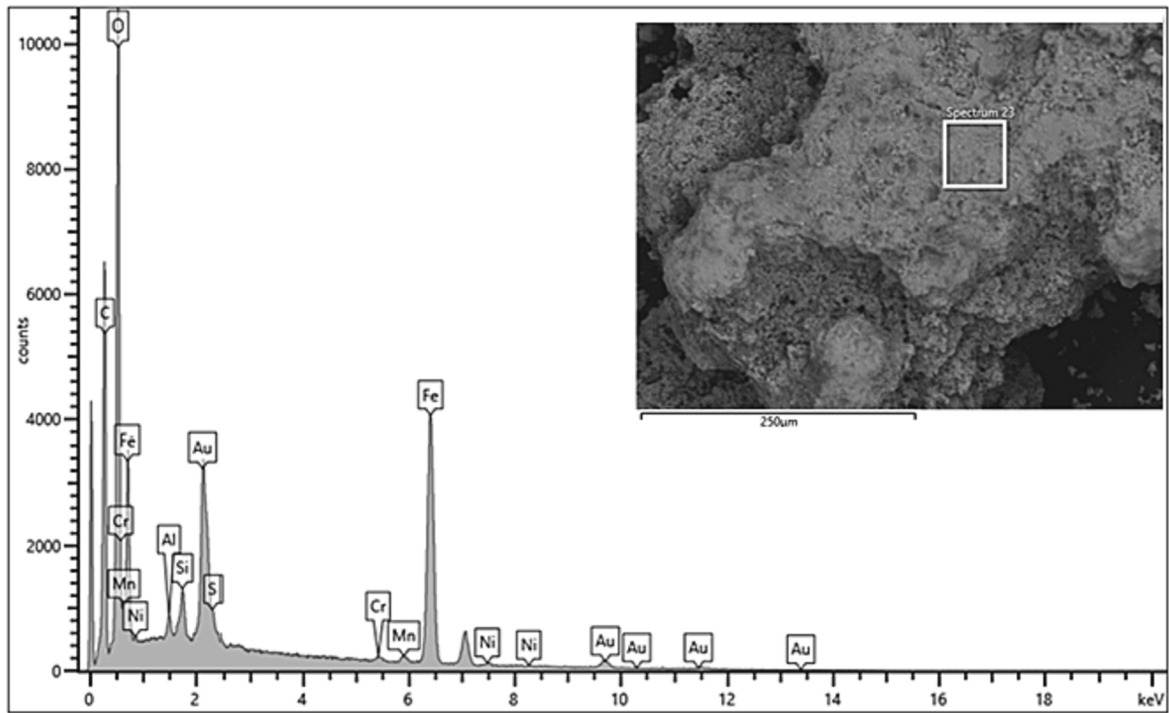
Fig. 13. Feature of the corrosion residues and the spectrum of SEM elemental analysis.

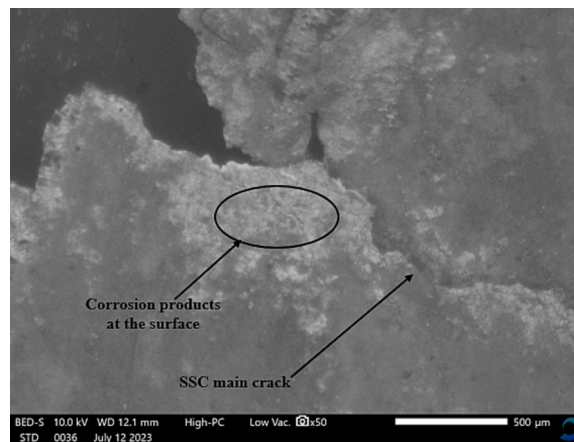
Fig. 14. SEM micrographs showing main crack at the surface due to sulfide stress cracking.

(hydrogen-induced cracks) and ultimate tube rupture through sulfide stress cracking mechanism when the material is subjected to high fluid pressures, as shown in Fig. 14. Fig. 15 shows the micro-cracks due to hydrogen voids, leading to hydrogen induced cracks. When the material continues being subjected to applied stress during service, the crack propagates, see Fig. 16. This mechanism of degradation has been reported by several researchers [11,25,26].

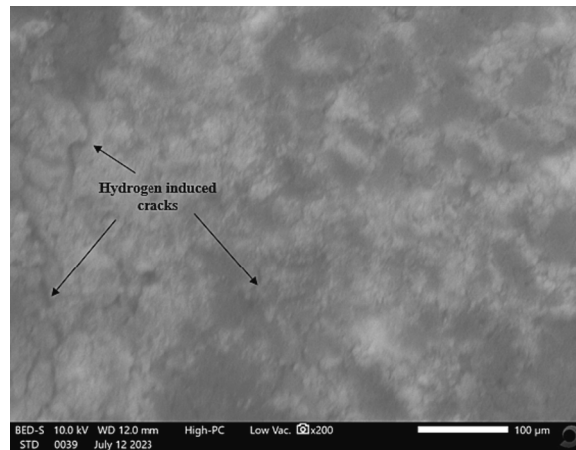
Fig. 15. SEM micrographs of hydrogen induced cracks in the failed tube material.

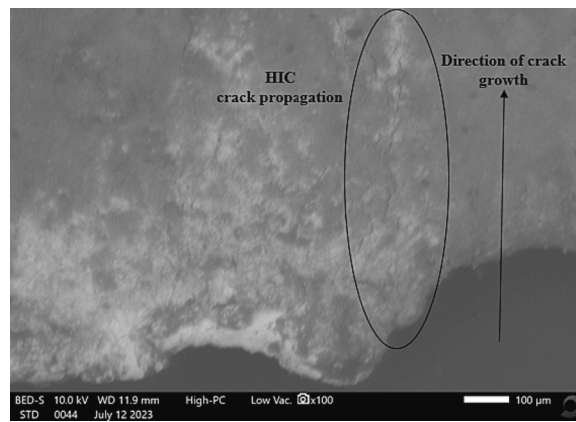
Fig. 16. SEM micrographs of the failed tube showing crack propagation.

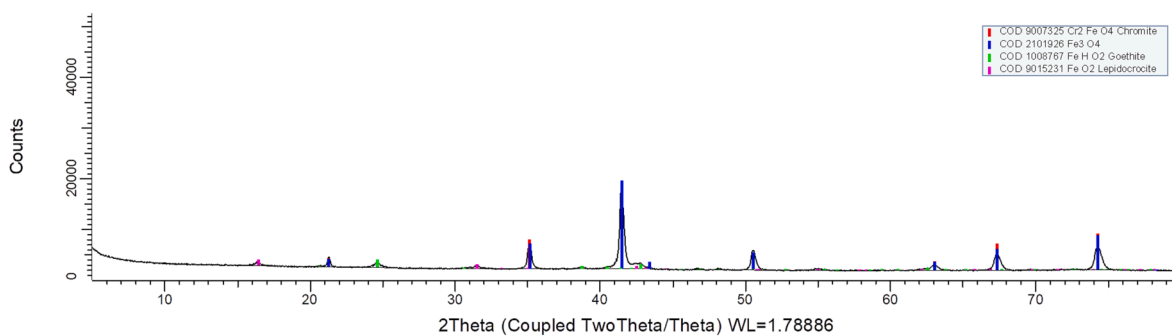
Fig. 17. XRD pattern of corrosion residues from CuNi10Fe failed tube.

The corrosion residue that was scraped from the heat exchanger is depicted in Fig. 17 using an XRD pattern. The spectrum reveals

the existence of several phases, including magnetite (Fe_3O_4), lepidocrocite (FeO_2), goethite (FeHO_2), and chromium iron oxide (Cr_2FeO_4).
