**OPTIMIZATION OF LASER CLADDED IN625/SS316L  
FUNCTIONALLY GRADED MATERIAL FOR HEAT  
EXCHANGER APPLICATIONS**

**MASTER OF SCIENCE  
(Mechanical Engineering)**

**JOMO KENYATTA UNIVERSITY  
OF  
AGRICULTURE AND TECHNOLOGY**

**2024**

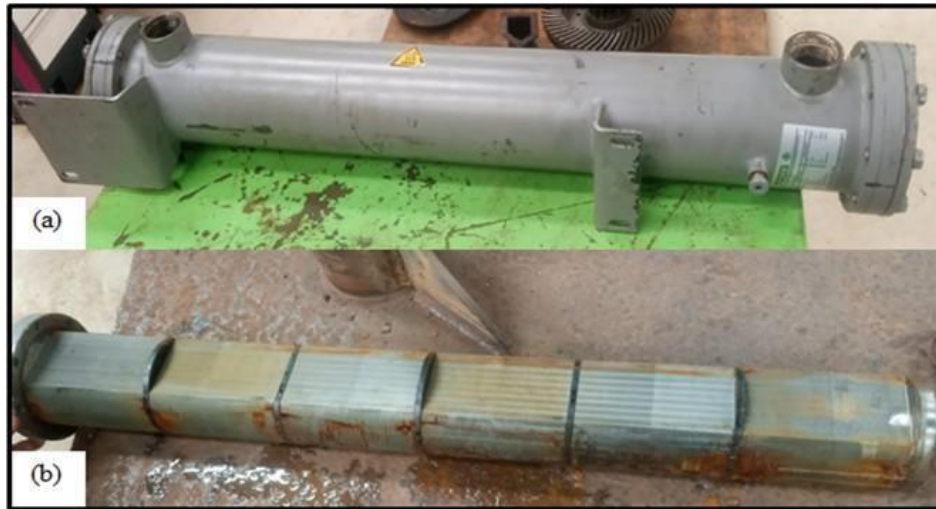
**Figure 1.3: Failed Shell and Tube Heat Exchanger (a) General View of the Shell (b) Internal Stacked Copper Tubes**

mechanisms such as corrosion erosion, corrosion cracking, and corrosion fatigue. Consequently, the failure analysis for a shell and tube heat exchanger (see Figure 1.3a) at Kenya's Olkaria V Power Station was carried out in the current study. The heat exchanger was made of copper tubes stacked into a tube bundle, as shown in Figure 1.3b.

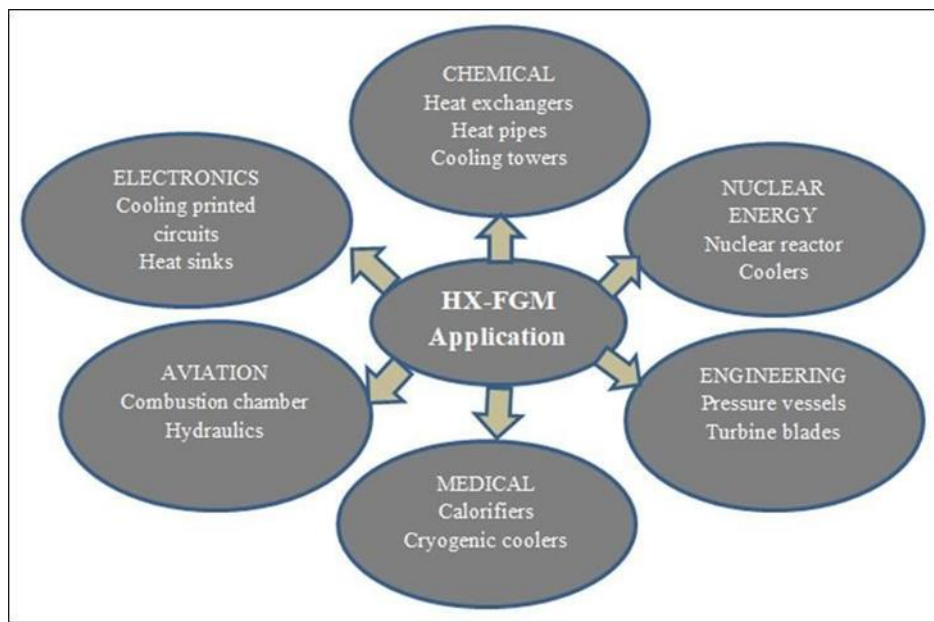
**Figure 2.9: Potential Fields of FGM Application in the Heat Exchanger Industry**

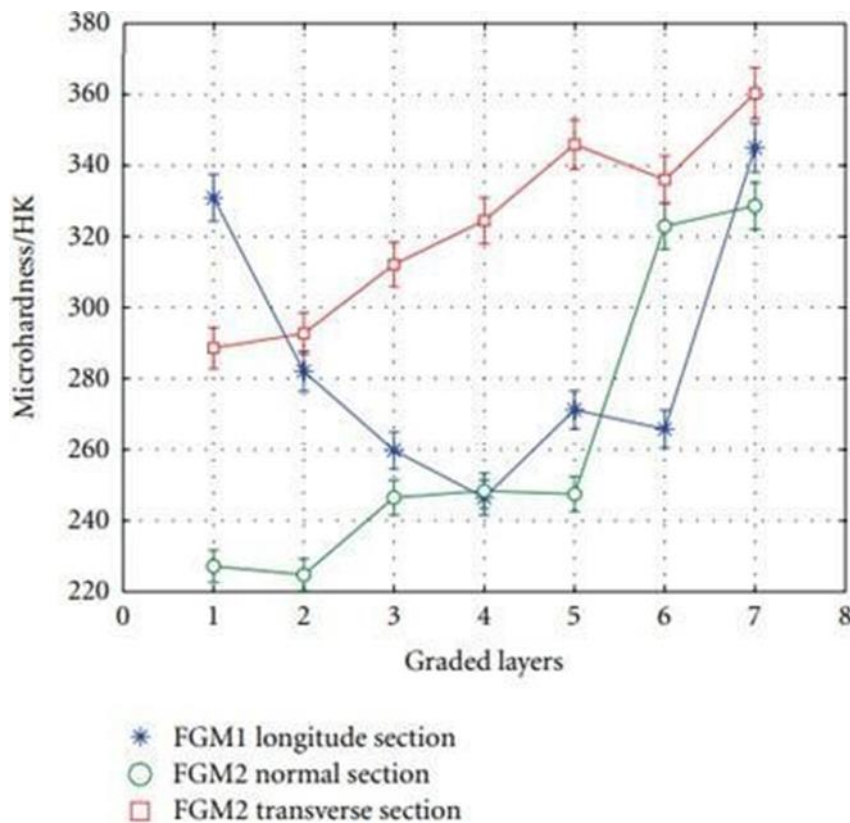
**Figure 2.11: Microstructural Variation on Functionally Graded SS316L/In718**

microhardness of the second FGM due to the Cr and Mo elemental reinforcements that caused solid solution strengthening, as seen in Figure 2.11. Additionally, the wear resistance of FGM<sub>2</sub> was examined, and it was discovered to have outstanding wear resistance for 100% layers of both SS316L and In718. The inclusion of reinforcing materials like Cr and Mo content can greatly increase the hardness of FGM coatings, which is desirable for erosion-wear and corrosion resistance in heat exchanger boiler tubes

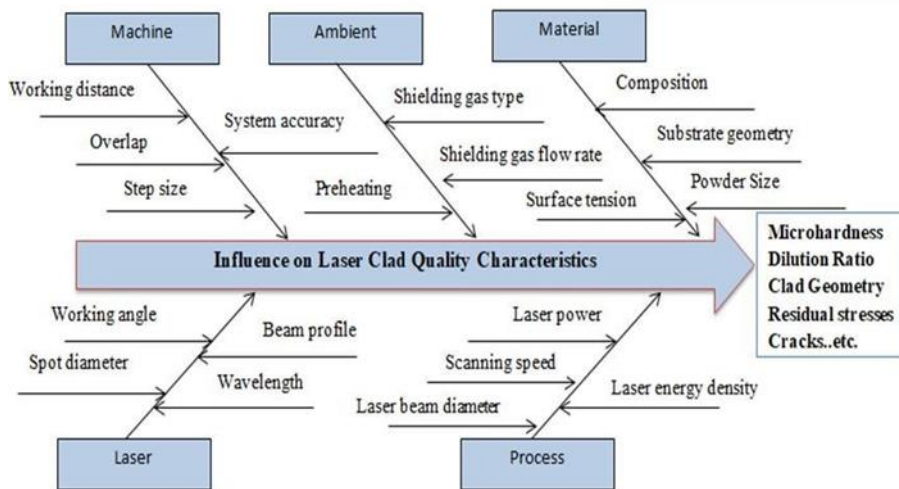
**Figure 2.15: The Ishikawa Fish-Bone Diagram Illustrating the Influence of Laser Cladding Process Parameters on Cladding Quality Characteristics**

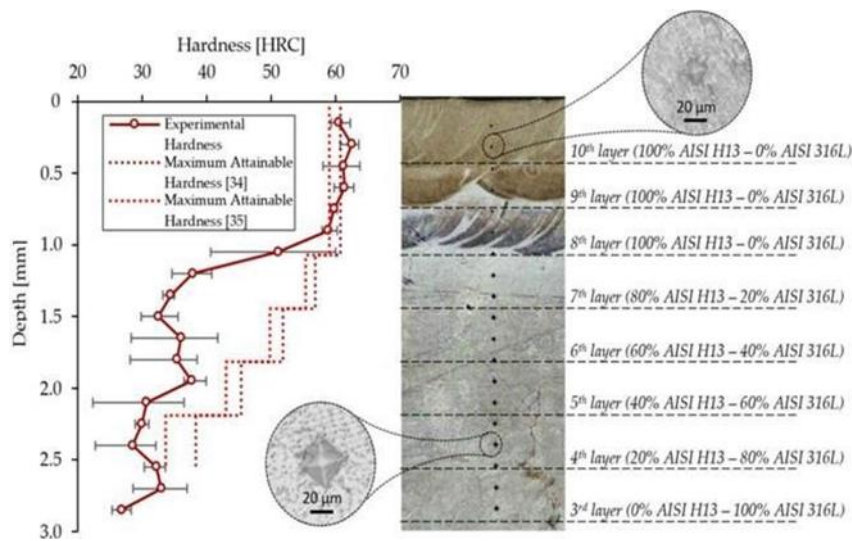
**Figure 2.18: Increasing Microhardness Profile Concerning Composition Grading**

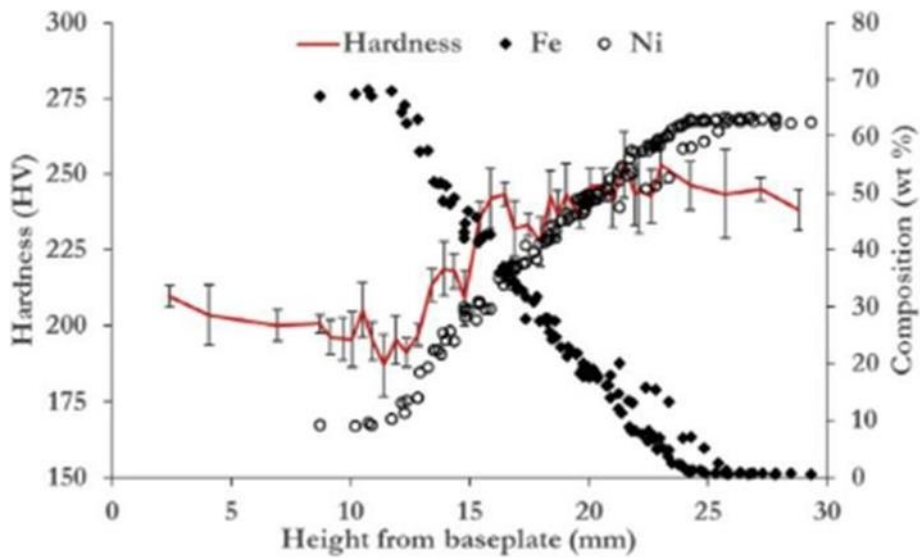
**Figure 2.19: Microhardness Profile Variation with Increasing Elemental Content**

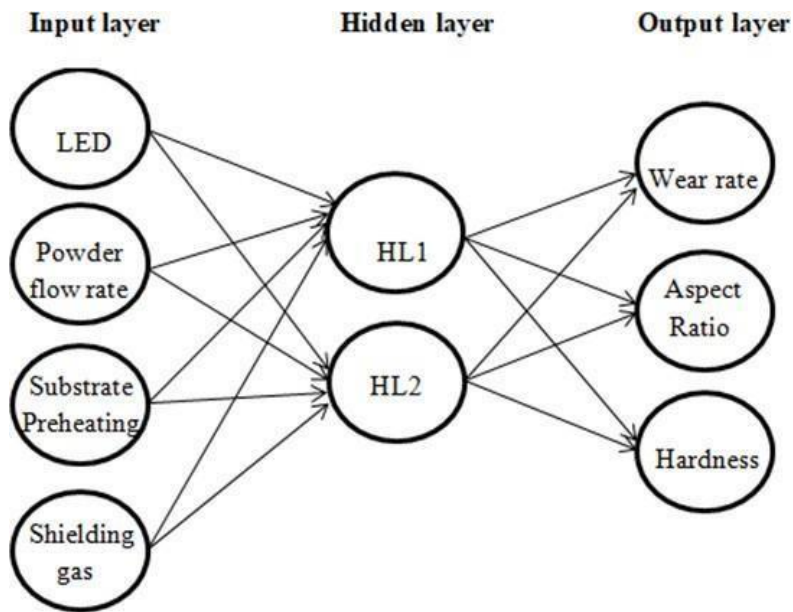
**Figure 2.20: Input to Output Structure of the Artificial Neural Network**

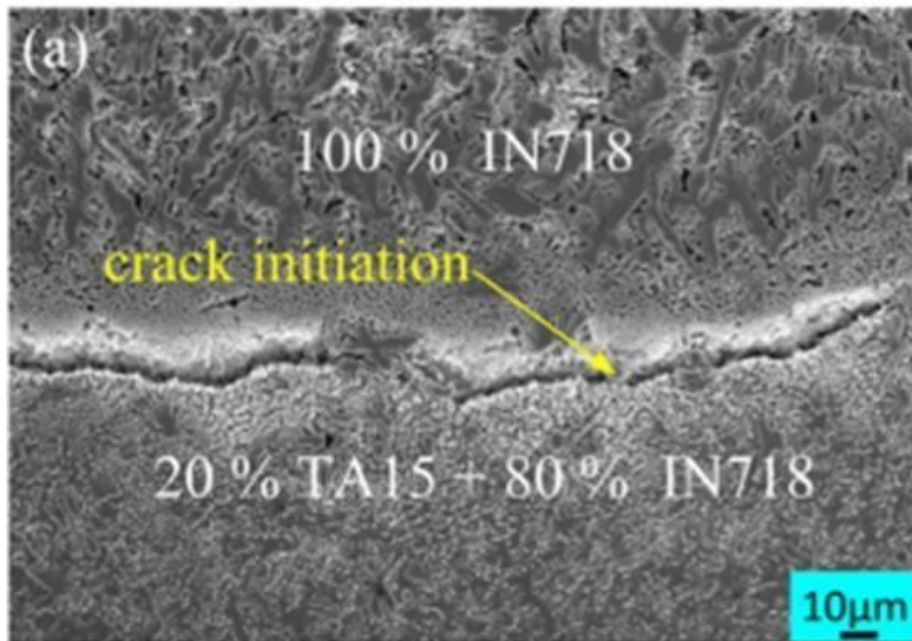
**Figure 2.22: Crack Propagation at the Interface of Functionally Graded Material**

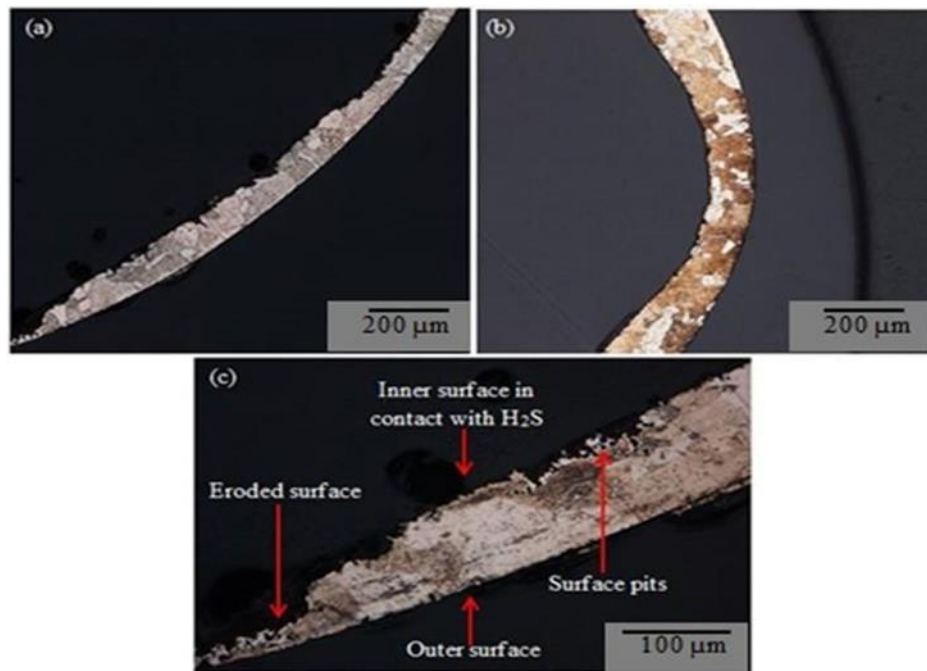
**Figure 4.7: Micrographs of Heat Exchanger Tubes (a) Failed Tube with Surface Defects (b) Intact Heat Exchanger Tube with Less Surface Distortion (c) Surface Cracks Pits Growing from the Inside**

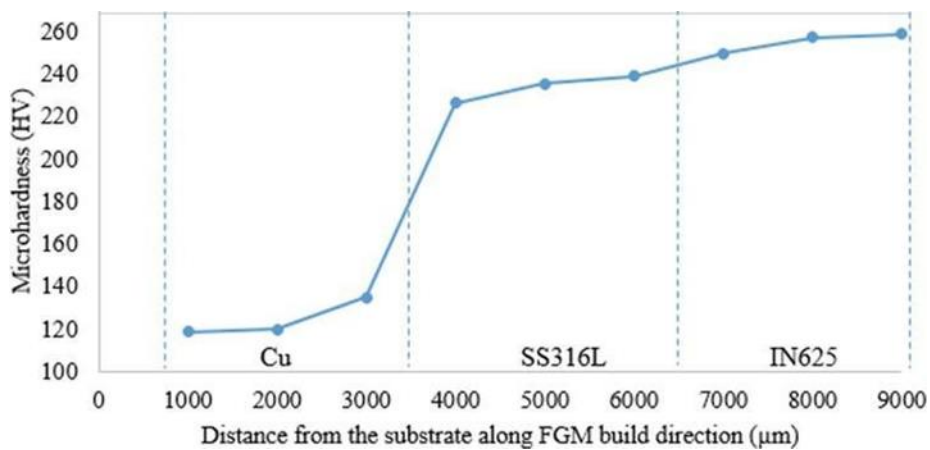
**Figure 4.29: Vickers Microhardness Profile of Cu Substrate and SS316L/ IN625 FGM along the Clad Build Direction**
