**EVALUATION OF MOBILE LIDAR TECHNOLOGY IN
ROAD ASSET MANAGEMENT: CASE OF KeNHA
HIGHWAYS IN NAIROBI CITY METROPOLIS**

**MASTERS OF SCIENCE
(Construction Engineering and Management)**

**JOMO KENYATTA UNIVERSITY
OF
AGRICULTURE AND TECHNOLOGY**

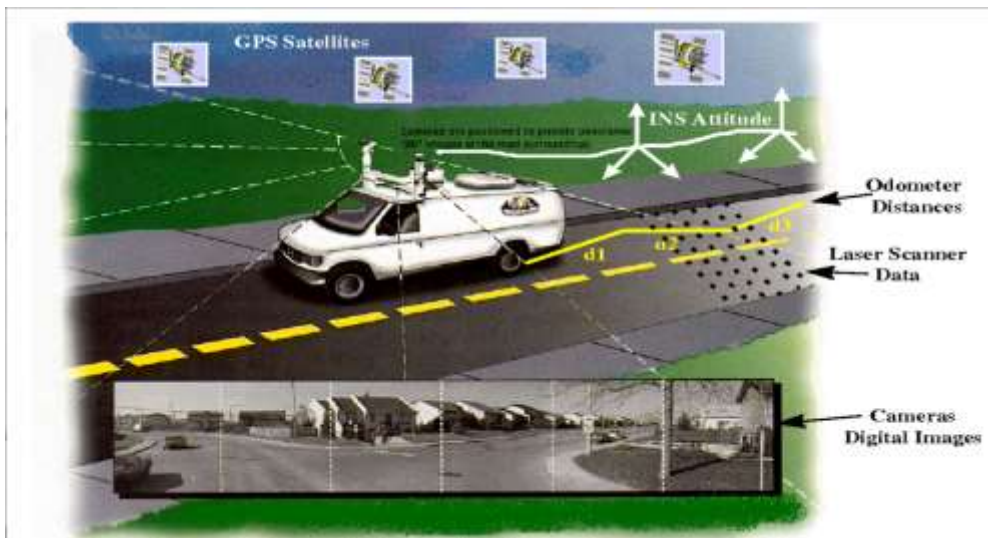
Figure 1.1: Schematic Diagram of Mobile LiDAR

Compared with other remote sensing technologies, LiDAR is more automatic, efficient, and accurate. Furthermore, it can work both during the daytime and at night because laser scanning is relatively independent of sunlight (Moselhi et. al., 2020). Since its introduction, LiDAR has been used for a wide range of applications, including high-resolution topographic mapping, 3D surface-modelling, infrastructure and biomass studies, archaeological site detection, remote monitoring and object detection. LiDAR technologies have become well-established surveying techniques for acquiring geospatial information because Global Navigation Satellite System (GNSS) technologies have been widely commercially used since the early 1990s (Beraldin et al., 2010). Closely followed by airborne LiDAR, terrestrial LiDAR (that is, the laser scanner is mounted on a tripod) and mobile LiDAR technologies have been rapidly developed. Figure 1.1 shows a schematic representation of a mobile LiDAR system with various components.

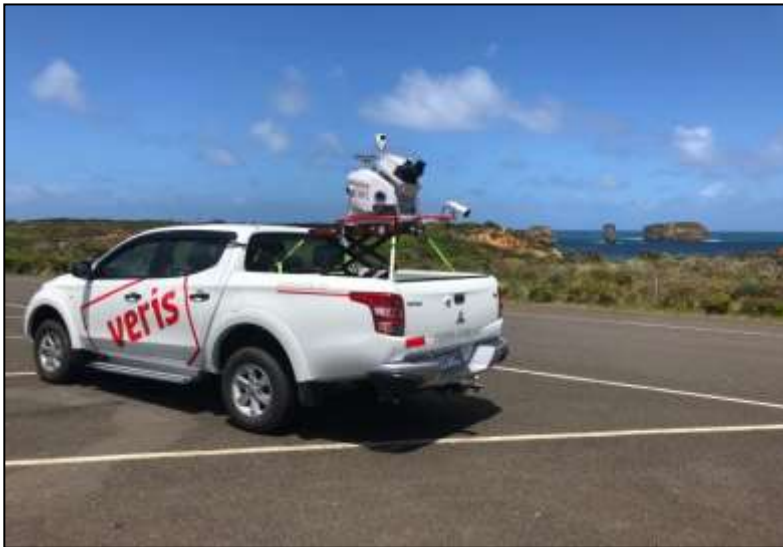
Figure 2.1: Mobile LiDAR System

Australia, represented as Figure 2.1, is a good example illustrating the vehicle-mounted systems for Mobile LiDAR.

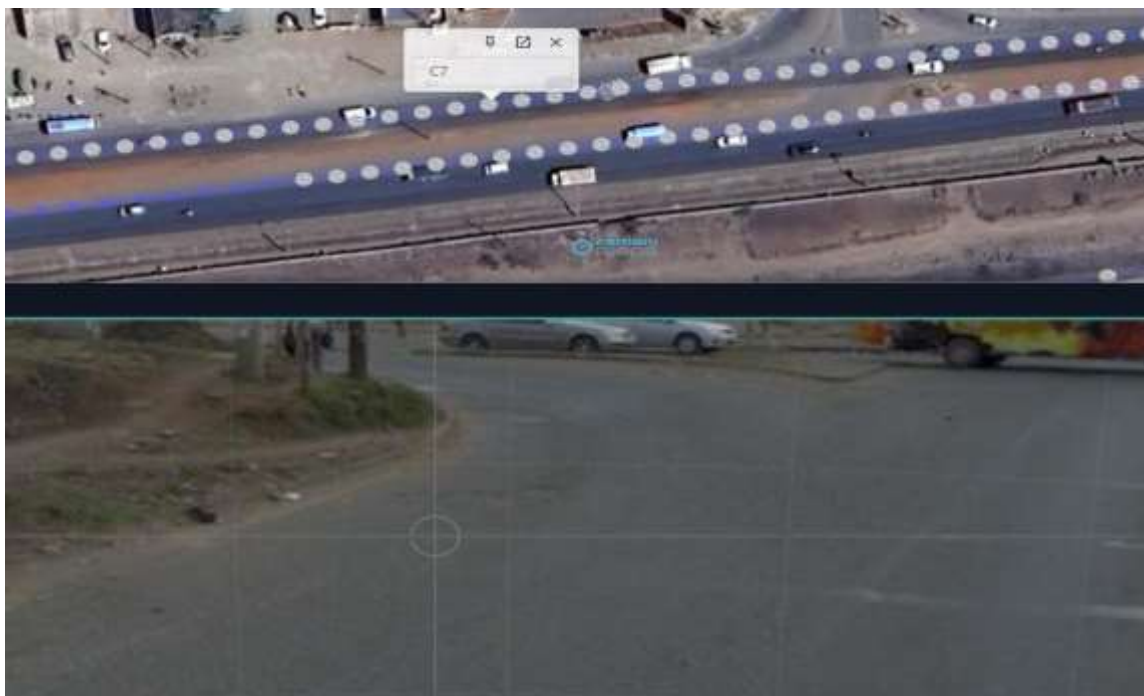
Figure 4.3: Road Surface Condition Highlighting Potholes along Mombasa Road

icons along the roadway. These icons highlight the prevalence and regular spacing of surface distress across both lanes, suggesting widespread degradation likely caused by high traffic volumes and the cumulative effects of weathering and load-induced stress. The image shows a marked section where these potholes appear frequently, aligning with previously discussed data in Table 4.2 that indicates potholes of substantial depth and width on this route. Such surface distress disrupts traffic flow, as vehicles must slow down or swerve to avoid these hazards, potentially leading to increased congestion and elevated risk of accidents. In the bottom half of the figure, a closer view provides additional context to the physical state of the road, depicting a rough, uneven surface with signs of erosion at the road edges, possibly due to poor drainage or subpar materials used in construction. The road edges appear worn and eroded, contributing further to the hazardous conditions, especially for smaller vehicles and motorcycles. This visual evidence highlights the urgent need for maintenance interventions to address these deteriorations, as the current state not only affects road safety and comfort but also accelerates further road wear, ultimately increasing long-term repair costs.

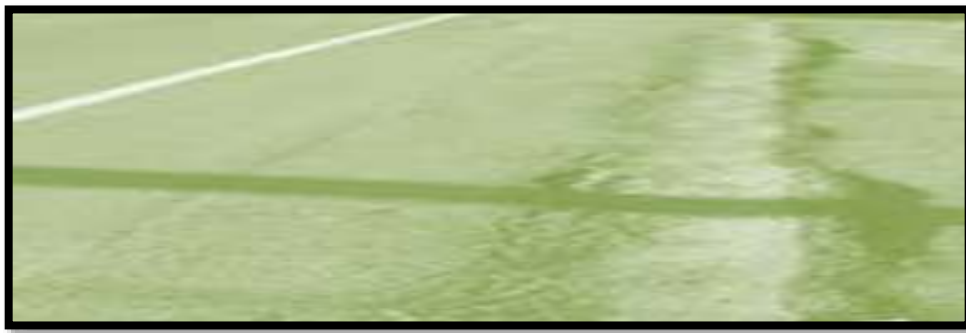
Figure 4.4: Rutting in Mombasa Road

Figure 4.4 depicts a section of Mombasa Road showcasing evident rutting along the road surface. Rutting is visible as longitudinal depressions or grooves that have formed within the wheel paths, indicative of significant wear resulting from repeated vehicular loads. This condition likely stems from a combination of high traffic volumes, especially of heavy vehicles, and potentially insufficient pavement thickness or substandard materials that fail to support prolonged loads effectively. The image demonstrates how the rutting is concentrated along specific paths, corresponding to the wheels' travel lines, suggesting that the road may be subject to frequent and concentrated traffic flow.

The rutting observed is concerning as it affects the structural integrity and safety of the roadway. Over time, such depressions can retain water, especially in rainy conditions, leading to a greater risk of hydroplaning for vehicles. Additionally, rutting disrupts the smoothness of the road surface, forcing vehicles to adjust their path within lanes, which can contribute to unsafe driving behaviours and potentially increase the likelihood of accidents. Rutting also exacerbates wear on vehicle suspension systems and tires, raising maintenance costs for road users. This type of degradation underscores the urgent need for pavement rehabilitation on Mombasa Road, emphasizing the necessity of engineering interventions that could include overlaying with more durable materials or enhancing the base structure to improve load-bearing capacity. As rutting continues to deepen and expand without timely repairs, it risks compounding the deterioration rate, ultimately leading to more extensive and costly repairs.

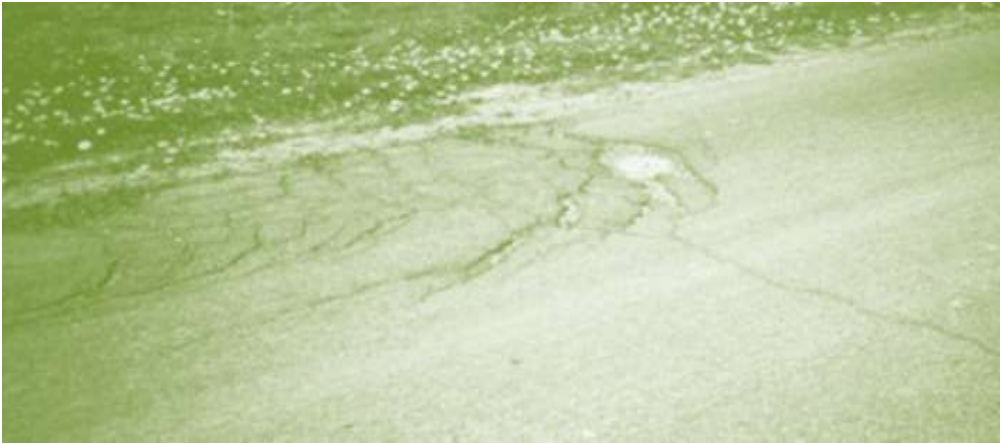
Figure 4.5: Potholes and Cracks along Mombasa Road

Figure 4.5 illustrates a segment of Mombasa Road showing the presence of both potholes and interconnected cracks, a common sign of pavement distress in heavily trafficked areas. The image reveals a pothole of moderate size, surrounded by a network of radial and intersecting cracks, suggesting that the surface layer of the road has undergone significant fatigue. These cracks, often referred to as alligator or fatigue cracks, typically emerge from repeated stress cycles induced by constant vehicular loading and environmental factors, such as temperature fluctuations and moisture infiltration. The proximity of the cracks to the pothole indicates that the underlying layers of the road may have lost cohesion and support, allowing water ingress and accelerating the degradation process.

This distress pattern is concerning, as it highlights structural weaknesses that can rapidly worsen without intervention. Potholes such as the one depicted in the image not only pose direct hazards to road users, potentially leading to tire blowouts and suspension damage, but also amplify the cracking in surrounding areas. As vehicles traverse over these distressed zones, they exert additional force on the compromised sections, which can cause existing cracks to widen and deepen, eventually forming more potholes. This cycle of deterioration suggests that Mombasa Road may require comprehensive resurfacing or reconstruction, particularly if underlying foundational issues are found to be contributing to the rapid wear. In the long term, without timely repairs, these surface and sub-surface weaknesses will lead to escalating repair costs, reduced road safety, and greater inconvenience for road users. Effective intervention would likely involve sealing the cracks, filling the pothole, and possibly reinforcing the subgrade to mitigate further structural damage and extend the pavement's service life.

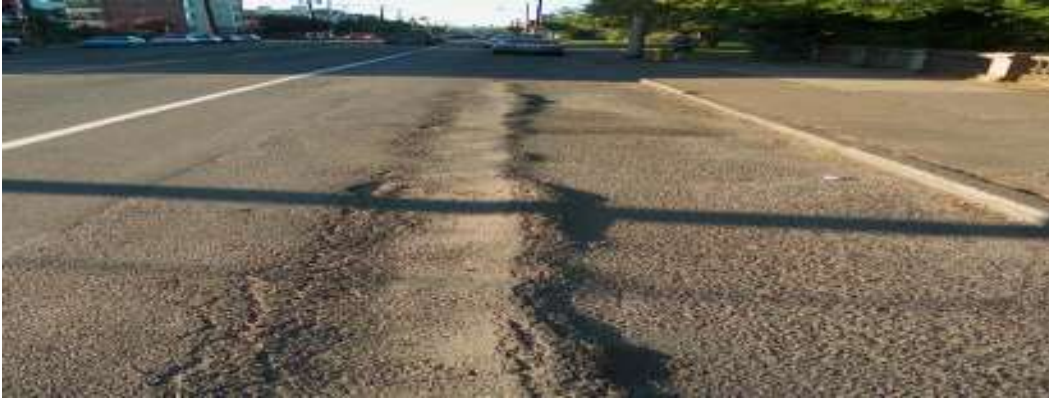
Figure 4.6: Ruttings and Cracks in Eastern Bypass

Figure 4.6 shows rutting and cracking on the Eastern Bypass, highlighting significant surface deformation that suggests both structural and material deficiencies in the road. The rutting, visible as pronounced depressions along the wheel paths, is indicative of excessive load impacts that have caused the pavement to sink and form grooves. This deformation is likely a result of repeated traffic loads, especially from heavy vehicles, which exert substantial pressure on the road surface, leading to the compaction and displacement of pavement layers over time. The rutting is not isolated but rather continuous along the wheel paths, suggesting that this segment of the Eastern Bypass has been subjected to persistent stress without adequate maintenance interventions.

The condition seen in Figure 4.6 underscores the need for structural improvements on the Eastern Bypass. Addressing the rutting and cracking would require not only surface repairs,

such as crack sealing and patching but potentially deeper rehabilitation to strengthen the base layer and improve load distribution. Figure 4.6 reveals that, without timely and appropriate repairs, these distresses will likely propagate, leading to further pavement failure, increased repair costs, and reduced road safety and functionality for all users.

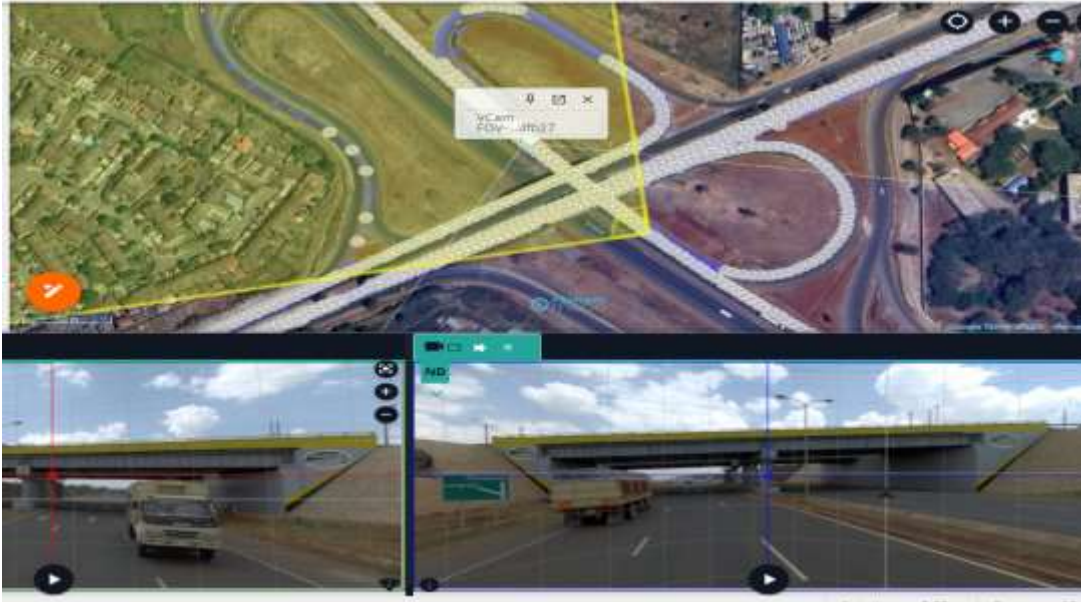
Figure 4.7: At Langata Interchange Showing Road Signage, Markings, Kerb and Streetlights

In summary, Figure 4.7 highlights how an integrated combination of signage, lane markings, street lighting, and curbs contributes to the operational efficiency and safety of the Langata Interchange. The aerial and ground-level perspectives together illustrate the functional design of this interchange, which prioritizes clarity in navigation and safety for all road users. This layout not only accommodates heavy traffic volumes but also provides a secure and organized environment for maneuvering, making the interchange a critical element of Nairobi's transport infrastructure.

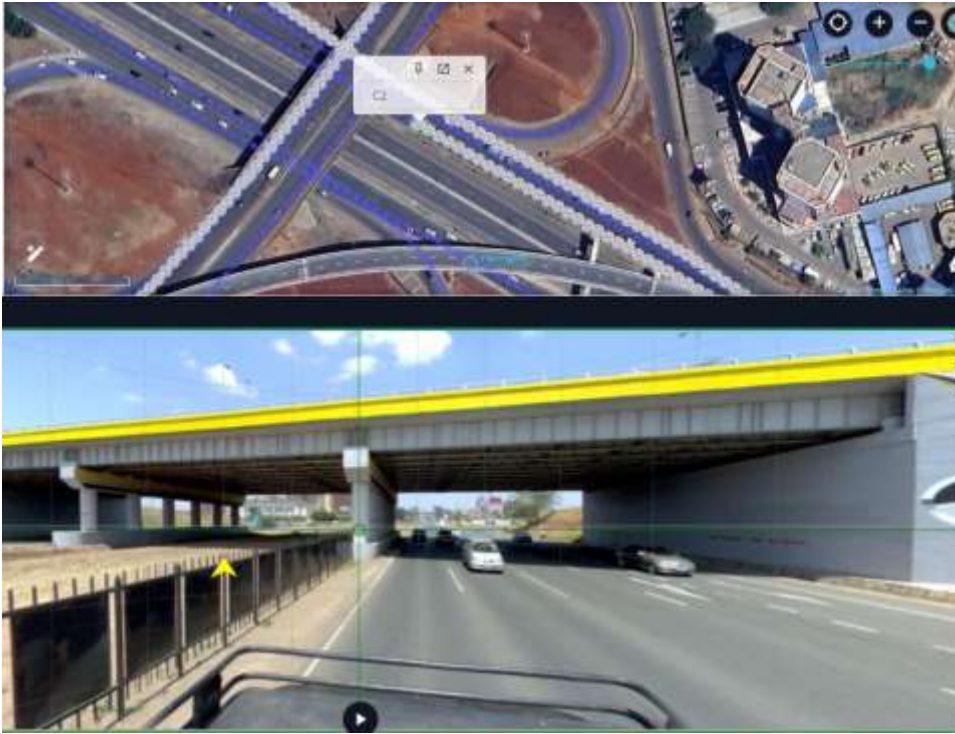
Figure 4.8: Mombasa road Interchange Showing the Road Markings, Kerb, Barrier as Well as Bridge Columns

Figure 4.8 provides an in-depth look at the Mombasa Road Interchange, showcasing essential elements such as road markings, curbs, barriers, and bridge columns that collectively enhance the safety, organization, and structural integrity of the interchange. The top aerial view reveals a complex network of intersecting lanes designed to facilitate smooth transitions for high volumes of traffic moving in multiple directions. Road markings are clearly visible, delineating lanes and guiding drivers through this intricate layout, thereby reducing the likelihood of confusion and collisions in areas where vehicles merge, diverge, or change direction. These markings are crucial for maintaining order, especially in high-speed environments where sudden lane changes can pose significant risks.

Overall, Figure 4.8 illustrates the functional and structural components that make the Mombasa Road Interchange a well-organized and secure infrastructure system. The road markings, barriers, curbs, and bridge columns are not merely individual elements but integral parts of a coordinated design that prioritizes safety, efficiency, and durability. Together, these features support the interchange's role as a major traffic hub, enabling it to handle the demands of heavy, multi-directional traffic while ensuring that vehicles can navigate the interchange safely and effectively.

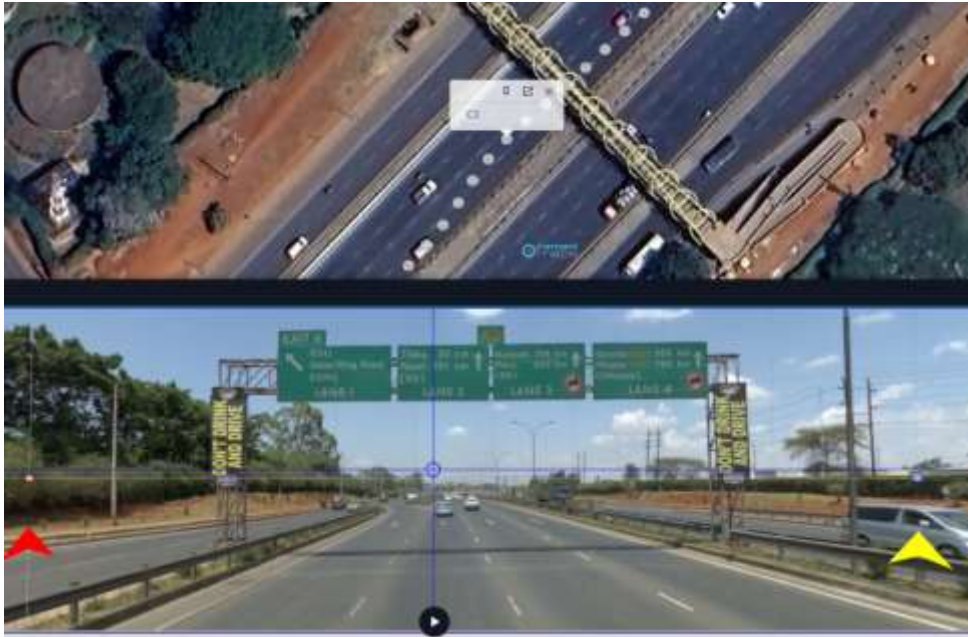
Figure 4.9: Thika Road showing the Road Markings, Signage, Guard Rails, Street Lights, Kerb

Figure 4.9 provides a detailed view of Thika Road, highlighting key infrastructural elements such as road markings, signage, guard rails, streetlights, and curbs, all of which contribute to the road's functionality, safety, and navigability. In the aerial view at the top, the broad multi-lane configuration of Thika Road is evident, designed to accommodate a high volume of traffic with a clear separation of lanes, allowing for efficient flow and reduced congestion. The road markings are distinctly visible, helping guide vehicles and enforce lane discipline, which is crucial for managing traffic on this major artery. These markings ensure that vehicles remain within designated lanes, minimizing erratic movements that could lead to accidents, especially on a busy road where speeds are often high.

Overall, Figure 4.9 illustrates a comprehensive approach to road design on Thika Road, integrating road markings, clear signage, guard rails, streetlights, and curbs to create a secure, organized, and efficient transportation environment. Each of these elements serves a specific function that contributes to the overall infrastructure's ability to handle high traffic volumes while maintaining safety and navigation ease for drivers. This thorough design facilitates smoother traffic flow, reduces accident risks, and enhances the usability of Thika Road as a vital route within the region's transportation network.

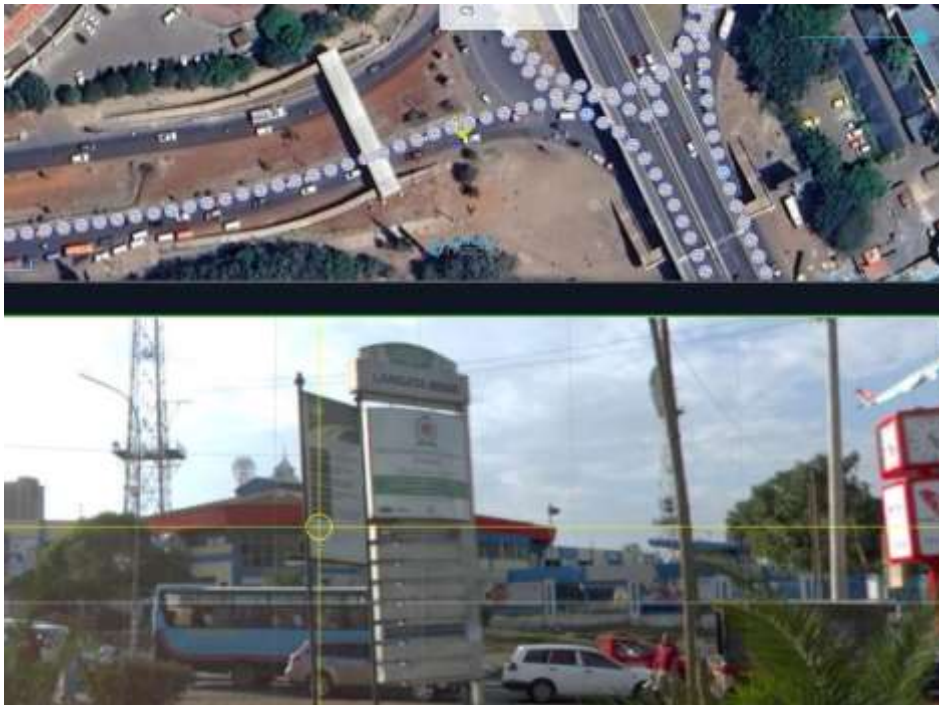
Figure 4.10: Mombasa Road Showing Signage, Utilities

Figure 4.10 shows a section of Mombasa Road where a section of 1 kilometre was captured. Findings show that all the hits captured were visible. However, some high-raised signs were missed in some data sets sections of the camera. Nevertheless, this can be avoided by titling the camera angle of elevation.

automatic methods of feature extraction were also utilized. Road Furniture attributes are stored in a GIS database.

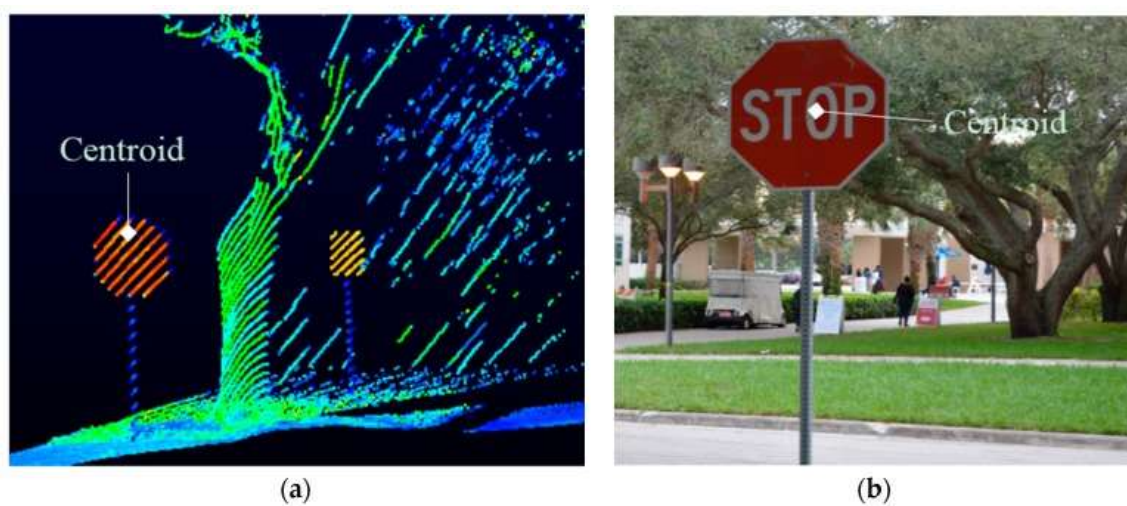
Figure 4.12: Extraction of Road Signs from Lidar Point Clouds and Images

returns. Hence, by using the height and dimension constraints, points that do not belong to road signs can be eliminated and the precise shape of the signboard can be established as captured in figure 4.12 and figure 4.13. It was also important to know the symbol on the road sign to add attribute information to the extracted spatial data. Since the content on the signboard cannot be well identified from the point cloud, geo-referenced images were used for this purpose. The location of the signboard can be determined on the set of referenced images by using the coordinate corresponding to the centroid of the signboard extracted from the point cloud.

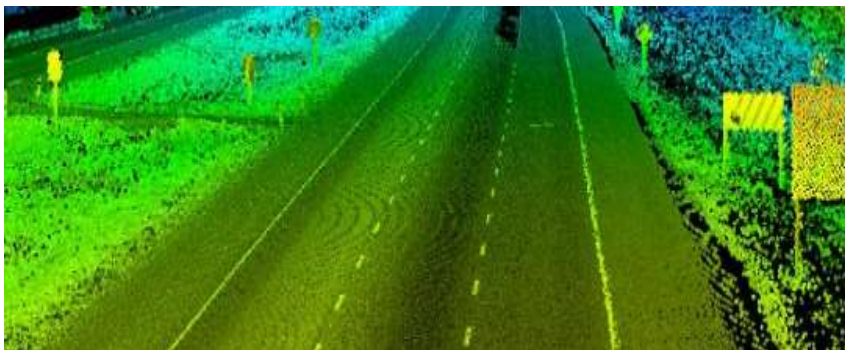
Figure 4.13: Point Cloud Showing Road Surface, Markings, Signage

Figure 4.13 illustrates a point cloud representation of a roadway, effectively capturing essential features such as the road surface, lane markings, and signage. The image employs a color gradient to differentiate various elements, with shades transitioning from green to blue, which likely correspond to height variations or intensity levels within the point cloud data. This gradient enhances the clarity of each feature, allowing for easy identification of road attributes. Lane markings are distinctly visible, running parallel along the roadway and providing structure and guidance for traffic flow. The precision of these markings within the point cloud data is crucial for applications such as autonomous vehicle navigation, where accurate lane positioning is essential for safe and efficient movement.

Additionally, the surface quality of the roadway can be inferred from the point cloud, as variations in height or texture may indicate irregularities, wear, or potential hazards on the road. This type of surface detail is valuable for maintenance planning, allowing infrastructure managers to identify areas requiring repairs or resurfacing. Overall, Figure 4.13 demonstrates the utility of point cloud data in capturing a comprehensive view of road infrastructure, from surface quality to essential road markings and signage. This level of detail supports a range of applications, from automated systems and urban planning to ongoing maintenance, making point cloud data an invaluable resource in modern road asset management and safety analysis.

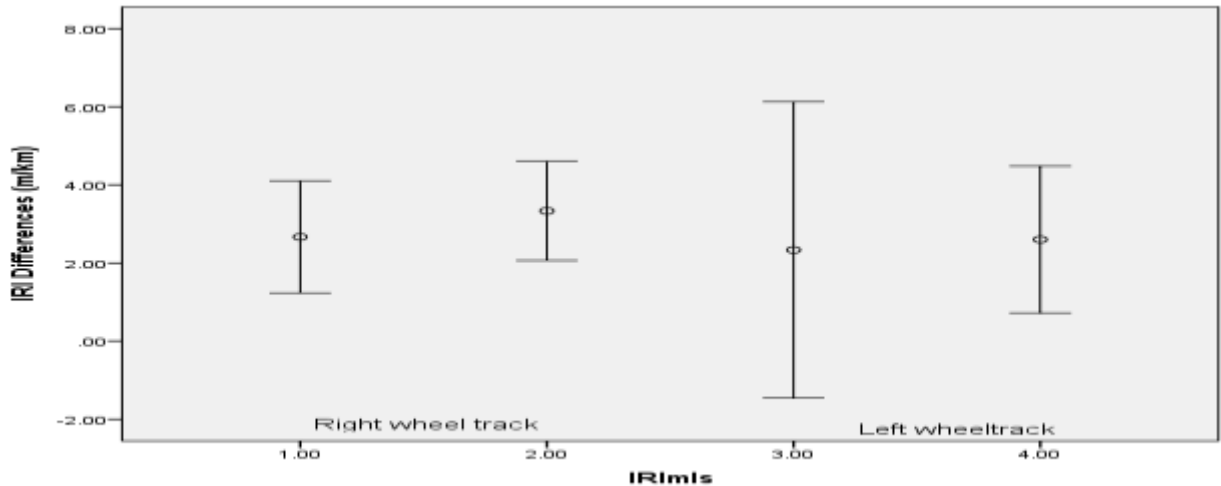
Figure 4.14: IRI Different Plot Graph

The importance of monitoring IRI differences between wheel tracks lies in its implications for maintenance strategies and road safety. Uneven wear across the wheel tracks can contribute to alignment issues for vehicles, create hazardous conditions during wet weather, and signal underlying structural vulnerabilities in the pavement. Therefore, this analysis underscores the need for road maintenance programs to consider not only the average roughness across both wheel tracks but also the individual conditions of each track. Addressing these differences can help improve the durability of the pavement, ensure a smoother ride for road users, and ultimately enhance the safety and longevity of the roadway infrastructure.

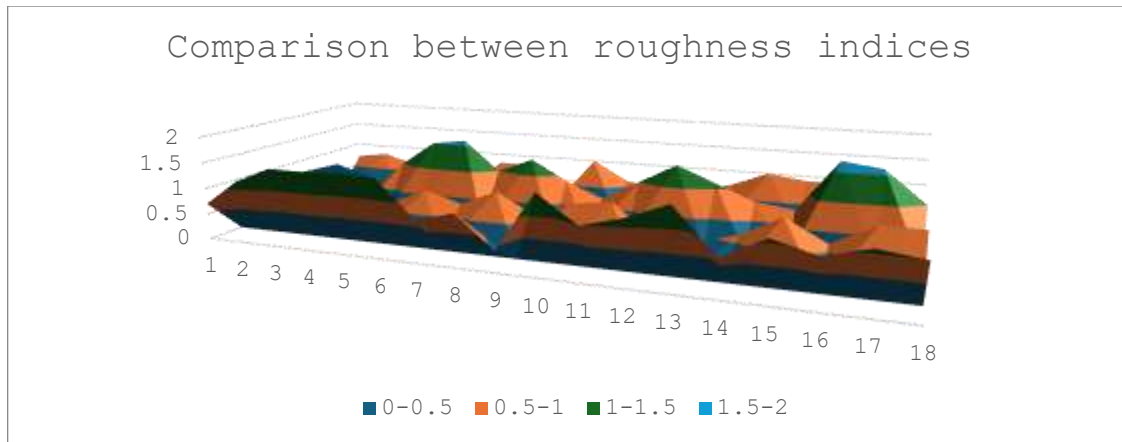
Figure 4.16: Wireframe Contours

Figure 4.16 showcases a wireframe contour plot comparing roughness indices across various road segments, offering a detailed visual of surface roughness patterns and their spatial distribution. The color-coded contour levels, corresponding to different roughness ranges (0-0.5 in light blue, 0.5-1 in orange, 1-1.5 in green, and 1.5-2 in darker blue), provide a layered representation that highlights areas of varying pavement conditions.

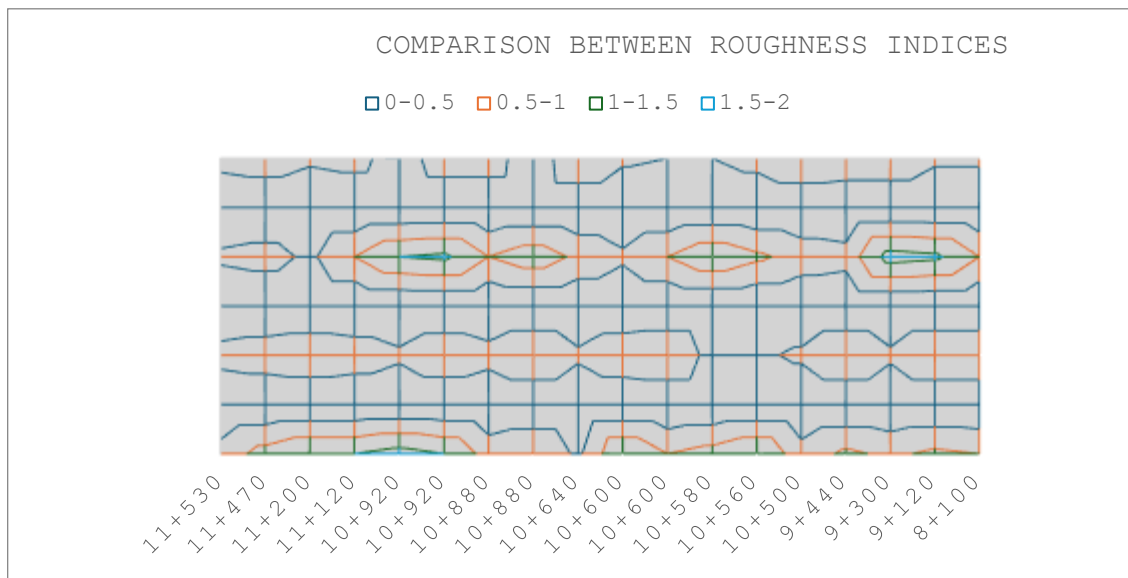
Figure 4.17: Wireframe Contours

assessment of pavement conditions across the road network, aiding in data-driven, efficient maintenance strategies.

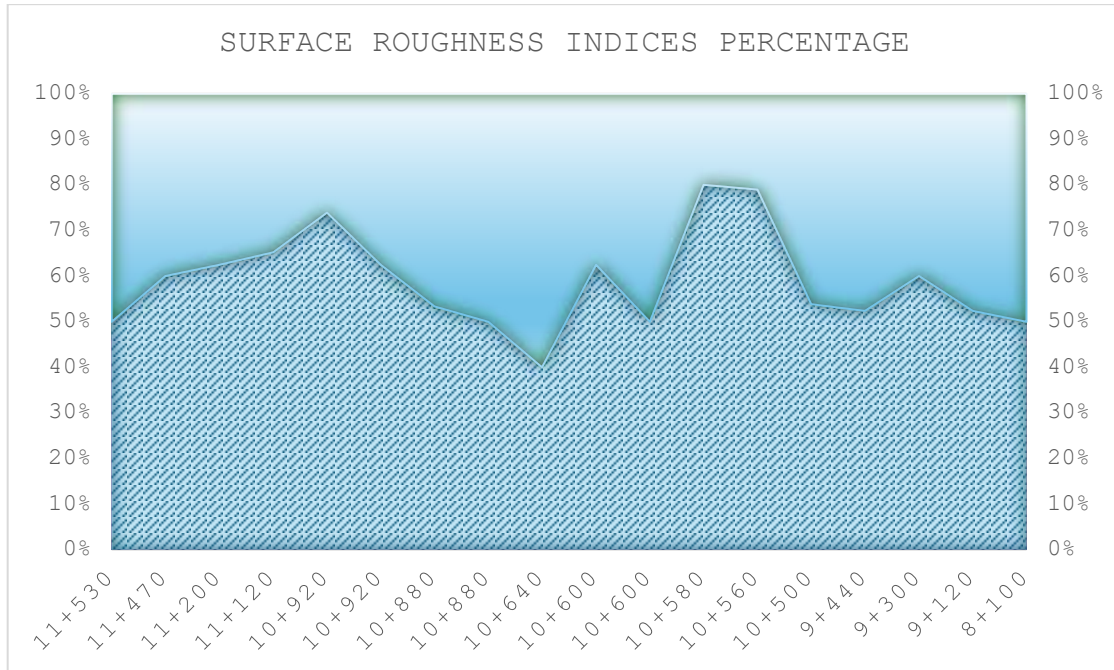
Figure 4.18: Surface Roughness Indices Percentage

Figure 4.18 presents a percentage-based visualization of surface roughness indices across various segments, highlighting the proportion of road sections that fall within certain roughness categories along the measured route. The plot provides a clear indication of roughness distribution as a percentage of the total roadway, offering insights into the prevalence of different roughness levels at each segment.
