Failure analysis of corroded heat exchanger CuNi tubes from a geothermal plant

This study examined the premature failure of cupronickel (CuNi10Fe) tubes in a shell-and-tube heat exchanger after five months of service. An investigation to identify the root cause of the tube burst was carried out using macroscopic and microscopic inspection, chemical analysis, and mechanical analysis. The optical microscopy (OM) and scanning electron microscopy (SEM) evaluation revealed crack propagation characterized by pits and inclusions at the tube surface. This was due to the diffusion of hydrogen ions into the material from the hydrogen sulfide (H₂S) rich geothermal environment. Furthermore, high tensile residual stresses of 172 MPa were recorded in the failed tube, leading to stress cracking in hydrogen-containing material. Additionally, the high sulfide content in corroded water and condensate samples suggests that the leading cause of tube rupture was through hydrogen embrittlement and sulfide stress cracking mechanism in the presence of hydrogen sulfide. Therefore, the use of laser cladding to protect tubes using functionally graded materials is recommended to mitigate degradation in aggre

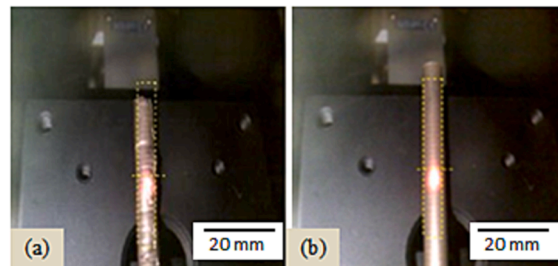
Fig. 4. Sample positioning for residual stress measurements (a) failed tube and (b) intact tube.

Residual stresses were measured using the μ -X360s Portable X-ray Residual Stress Analyser (Pulstec Ltd, Japan). Table 1 summarises the parameters adopted for the residual stress measurements. The residual stresses were measured for sample T1 and T2. Residual stresses were measured at the tube surface along the tube's circumferential direction, see Fig. 4.

Fig. 6 (a) that the failed tube has tensile residual stresses of positive 172 MPa, while the intact tube has compressive residual stresses of negative 56 MPa. The failed tube’s distortion (Fig. 6b) is also higher than the undamaged tube’s due to high-stress concentrations, measuring 2.823 mm, which supports the explanation behind the expanded region of the failed tube observed in Fig. 4b. Furthermore, the intact tube is more accurately depicted in Fig. 6b with a circumference that is close to circular, as opposed to the failed tube Fig. 6b with a more distorted shape. In contrast, the failed tube’s peak profile in Fig. 6c featured a thick peak profile with a yellow–red line signifying high-stress intensity.

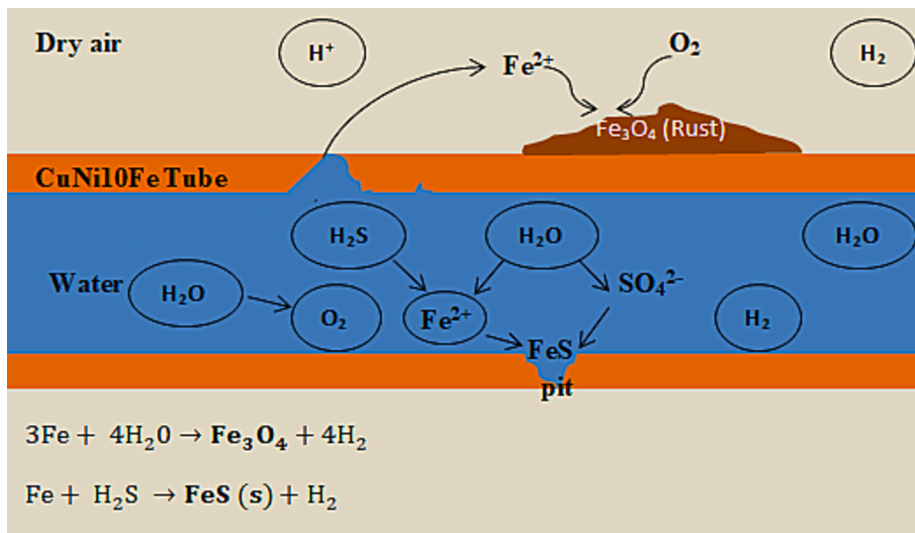
Fig. 9. Schematic illustration of the corrosion process of CuNi10Fe.

The pit formation of CuNi pipes due to iron oxidation led to the depletion of iron in the presence of H_2S , which gave room for the diffusion of hydrogen ions and susceptibility of embrittlement, resulting in hydrogen-induced cracking in sulphide concentrated environment. This is evidenced by the black and orange-brown colour of the corrosion residues that were examined, referred to as iron oxide, and commonly known as rust. Furthermore, the presence of sulphur was observed to be excessive. It can lead to sulfidation that results in sulphide or sulphate formation due to the compounds triggered by the presence of Fe and Ni, which are significant contributions and responsible for acceleration corrosion in copper-nickel tubes and cracking. Thus, the presence of iron in the corroded powder could mean iron was oxidized at the anode to its ferrous form and reacted with steam containing hydrogen sulphide at the cathode, forming an unprotective iron oxide (Fe_3O_4). Fig. 9 also shows the degrading mechanism in the presence of magnetite, which is a product of iron oxide, is formed on the steam side of the boiler tubes under high pressure and high temperature in a humid environment.
